USAAEFA PROJECT NO. 83 - 21

ARTIFICIAL AND NATURAL ICING TESTS YEH - 60A QUICK FIX HELICOPTER

JUNE 1984

FINAL REPORT

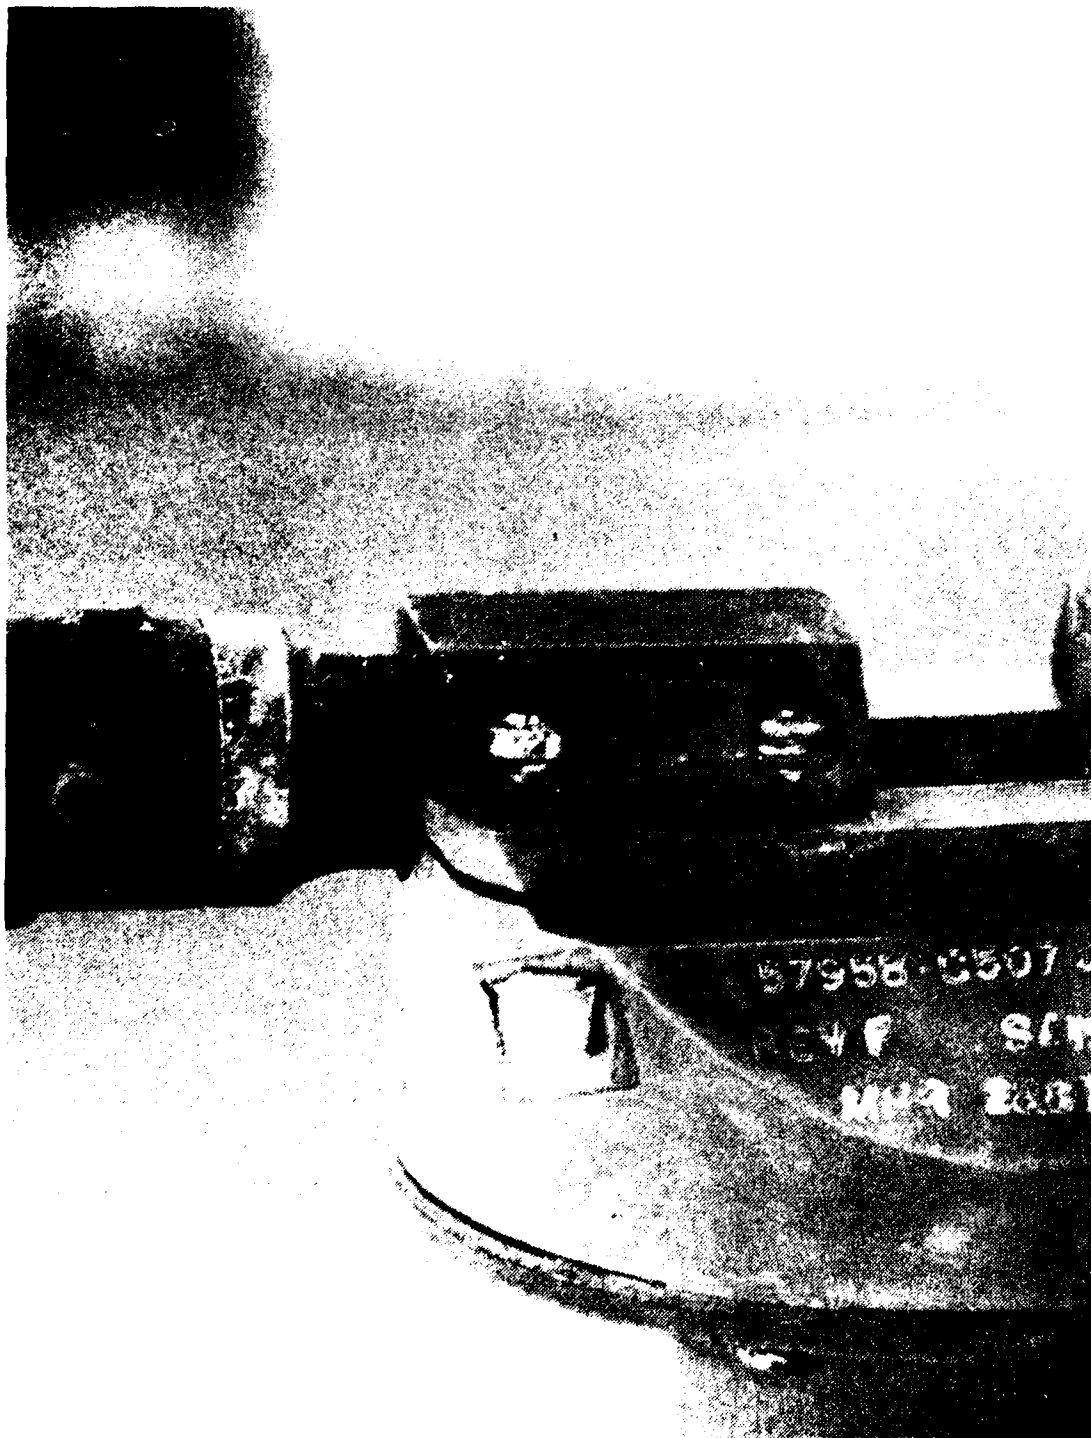
a. Damage to the unheated DF antenna element mounts and phenolic blocks caused by excessive element oscillations induced by ice accumulation (para 15).

15. The ice accretion characteristics of the unheated DF dipole antennas were evaluated at the specific test conditions listed in table 1, appendix F. Ice accumulation caused the unheated DF antennas to oscillate. Flight in artificial icing conditions (1.0 gm/m^3 LWC at -20.0°C) was terminated after 28 minutes behind the HISS when the chase aircraft observed ± 4 inch tip oscillations of the DF antenna elements. Post flight measurement recorded 1.5 inches of ice on portions of the DF antenna elements (photo 4, app H). No damage to the DF antennas or their mounts was noted. However, post flight inspection of the DF antennas after 74.5 minutes in natural icing conditions (0.35 gm/m^3 LWC at -11.0°C) revealed that the phenolic support block of the front right DF antenna (#3) had cracked (photo 5, app H) and the mounting screws for the antenna elements of the rear right antenna (#4) had loosened (photo 6, app H). Further testing of the unheated antenna configuration was suspended following this flight. The Equipment Performance Report submitted by USAAEFA on the incident is included in appendix G. The effect of ice accumulation on the proper function of the DF system was not tested. The damage to the unheated DF antenna element mounts and phenolic blocks caused by element oscillations induced by ice accumulation is a deficiency. Further testing of the effect of ice accumulation on the proper function of the DF system should be accomplished.

Photo 5. Cracked Phenolic Block Unheated Direction Finding Antenna #3
Natural Icing - 0.35 gm/m^3 LWC, -21.5°C , 75 Minutes, Flt #4

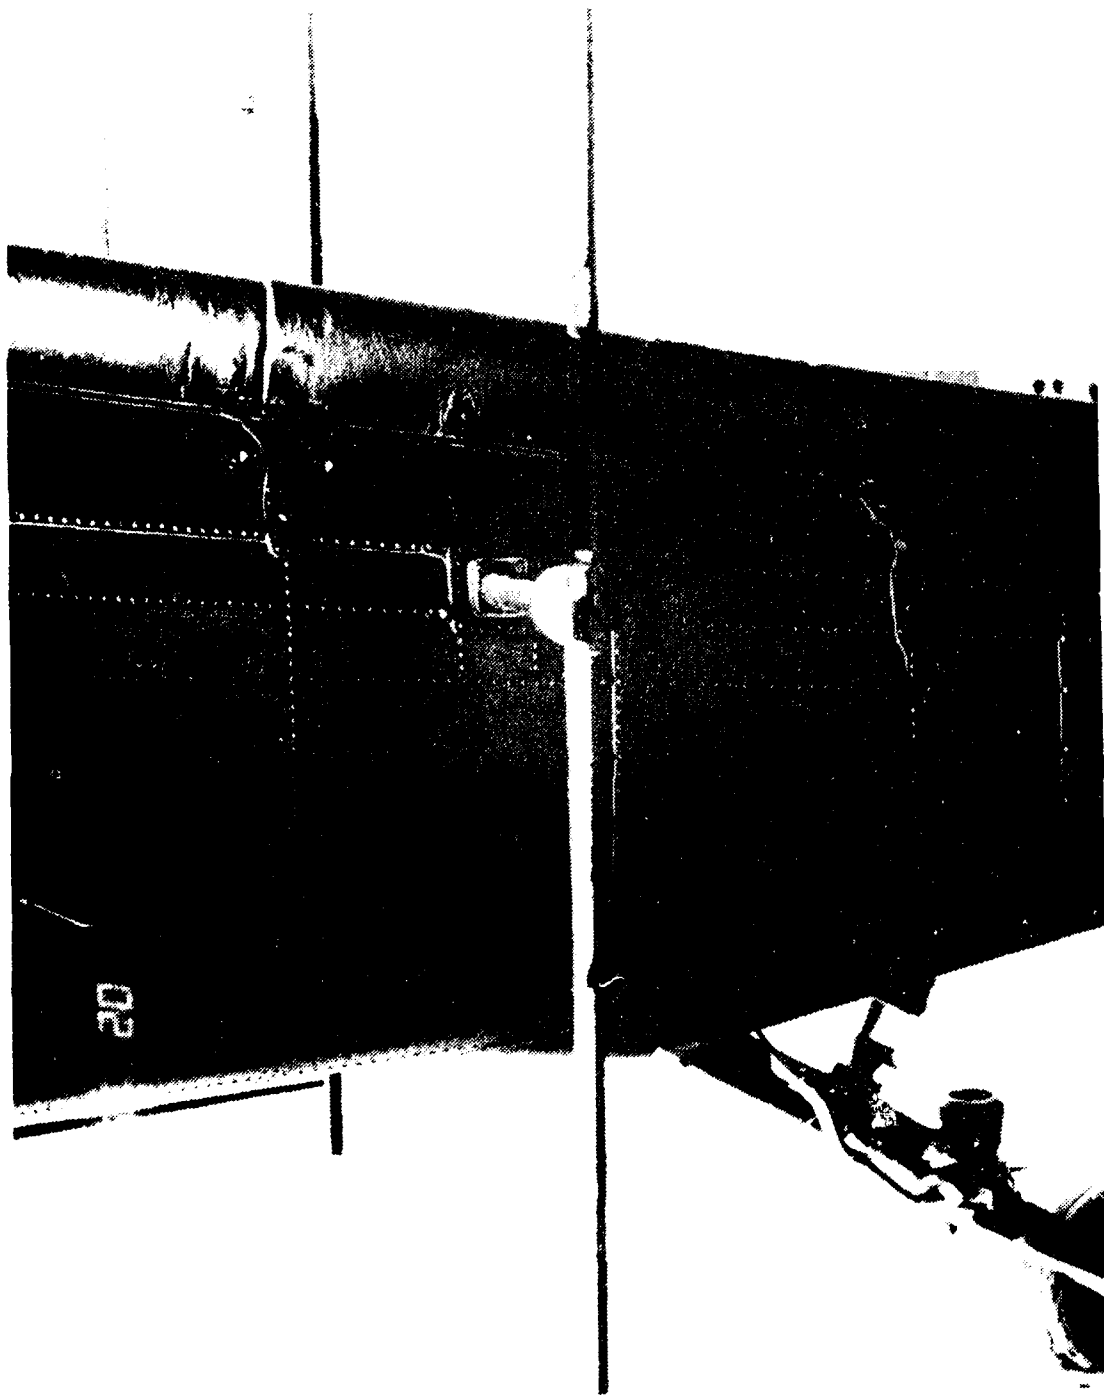
Photo 4. Ice Accretion Unheated Direction Finding Dipole Antenna -
Artificial Icing - 1.0 gm/m^3 LWC. -20.0°C . 28 Minutes. Flt #1

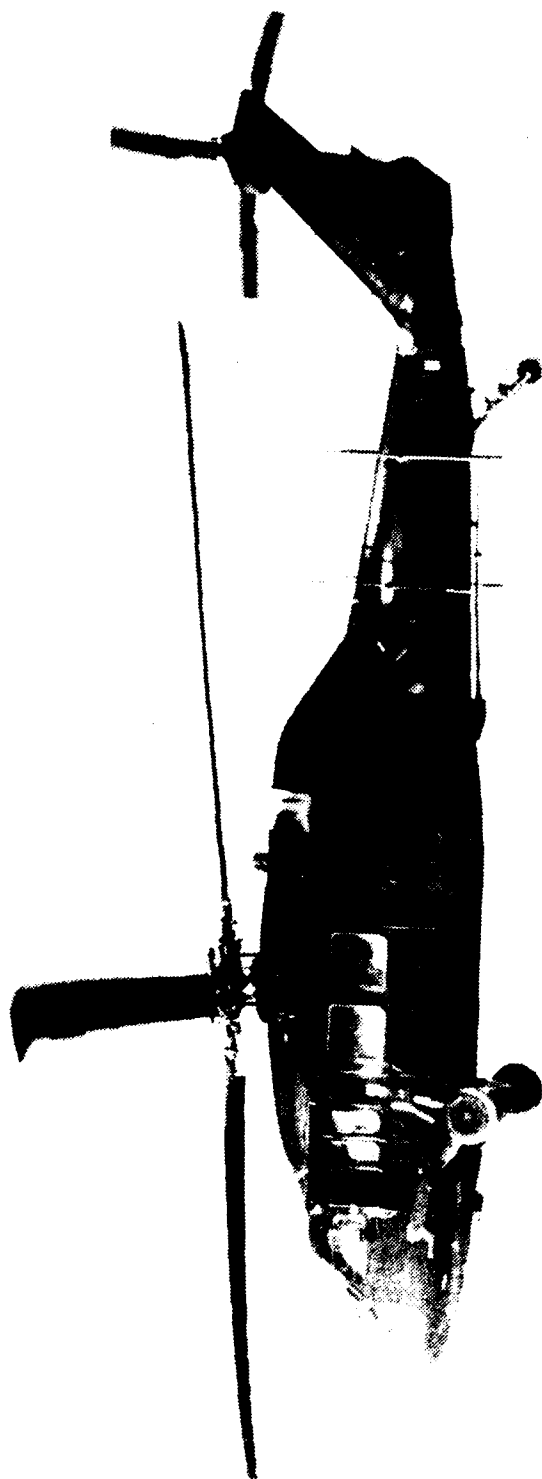
Photo 3. Airframe Ice Accretion - Artificial Icing -
1.0 gm/m³ LWC. -20.0°C, 28 Minutes. Flt #1

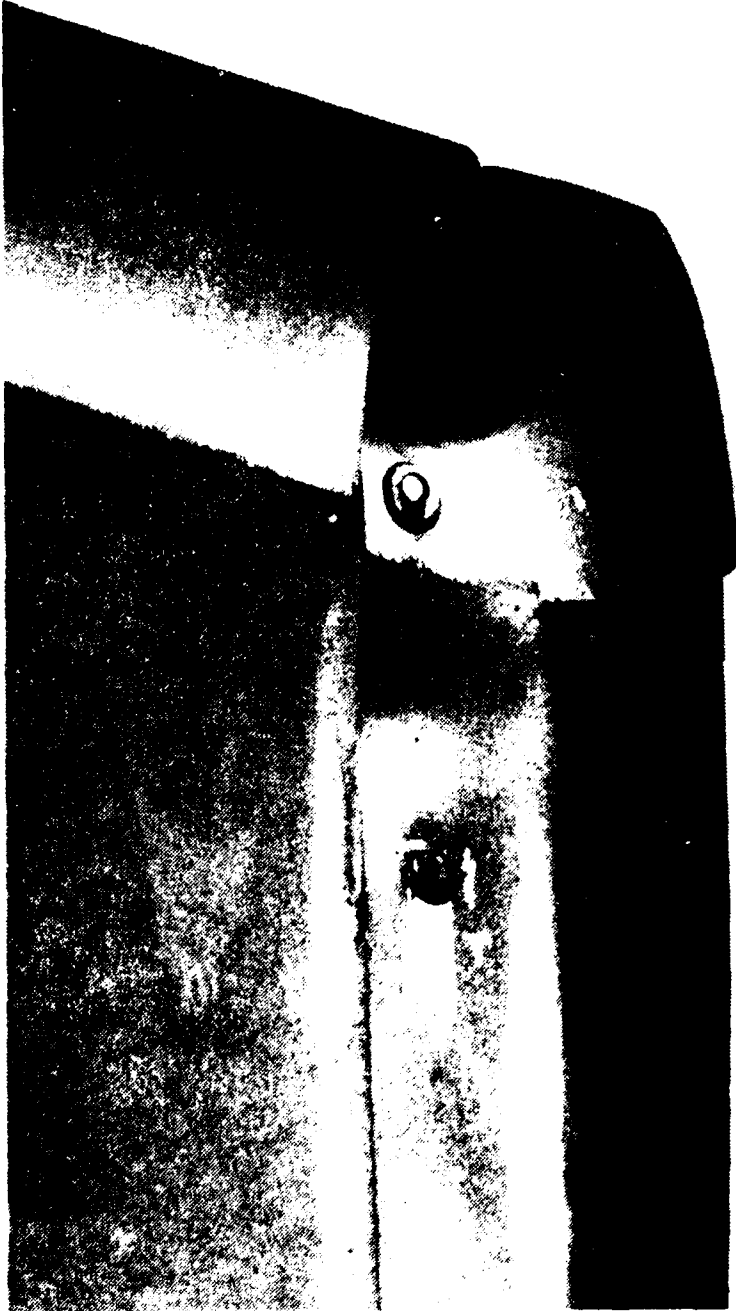
i. Paragraph 34e: The tail rotor tip cap damage is considered to be caused by main rotor blade shed and sheds from other locations of the helicopter's airframe where ice accretes. This type of damage is normal and can be expected under icing conditions. The maintenance requirements associated with tip damage are considered acceptable. Suitable means to control shed ice to preclude such damage is not available at this time.

13. Tail rotor tip caps were damaged during flights in both artificial and natural conditions. During a natural icing flight at -5.5°C and LWC of 0.25 gm/m^3 two tail rotor tip caps were damaged and required repair. During an artificial icing flight at -6.5°C and LWC of 1.0 gm/m^3 , another tip cap was damaged requiring repair (photo 2, app H). In neither case did the damage cause a noticeable increase in vibrations or change in aircraft handling characteristics. The Equipment Performance Report submitted by USAAEFA on the incident is presented in appendix G. Ice impact damage to the tail rotor tip caps is a shortcoming.

Photo 2. Tail Rotor Tip Cap Damage - Artificial Icing -
1.0 gm/m³ LWC, -6.5°C, 43 Minutes, Flt #13

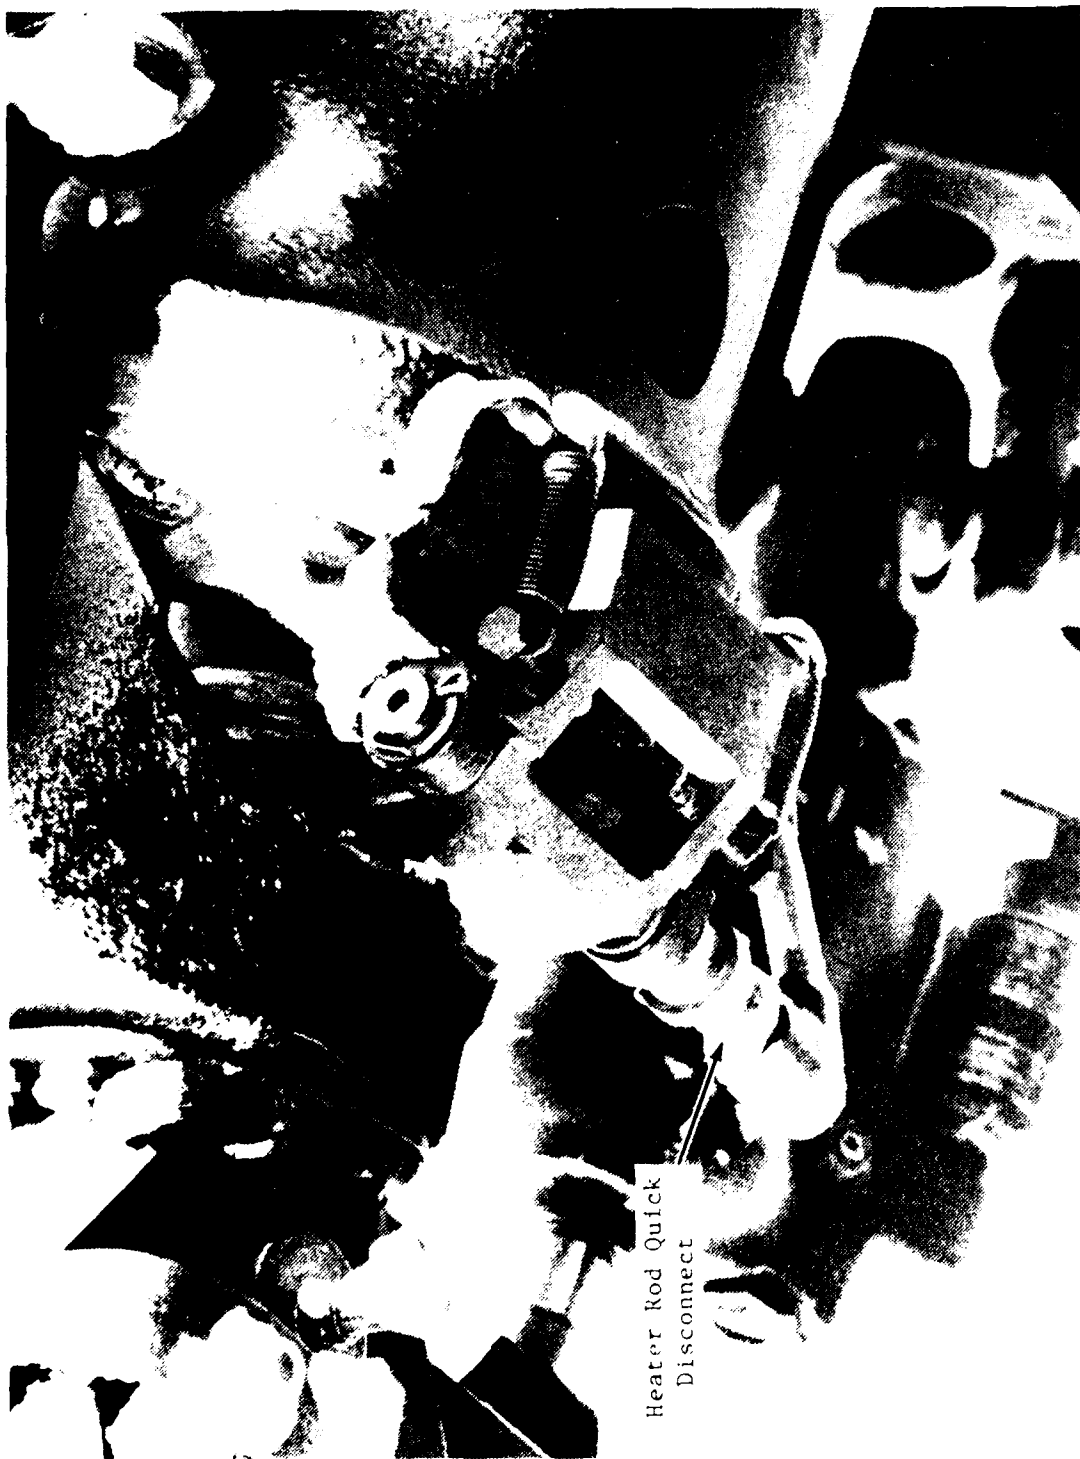
12. The ice accretion and operational characteristics of the droop stops were evaluated throughout these tests. The droop stops installed on the test aircraft were referred to as the improved droop stop configuration (FSN 70105-08151-045). Anti-ice protection was provided by an electrically heated rod inserted through each droop stop pivot bolt. The improved droop stops returned to the retracted (shutdown) position (photo 1, app H) after all tests, incurred no damage, and always seated completely. The improved droop stops operated satisfactorily at all conditions tested.

Photo 1. Ice Accretion Improved Droop Stop - Natural Icing -
1.0 gm/m³ LWC, -20°C, 75 Minutes, Flt #4

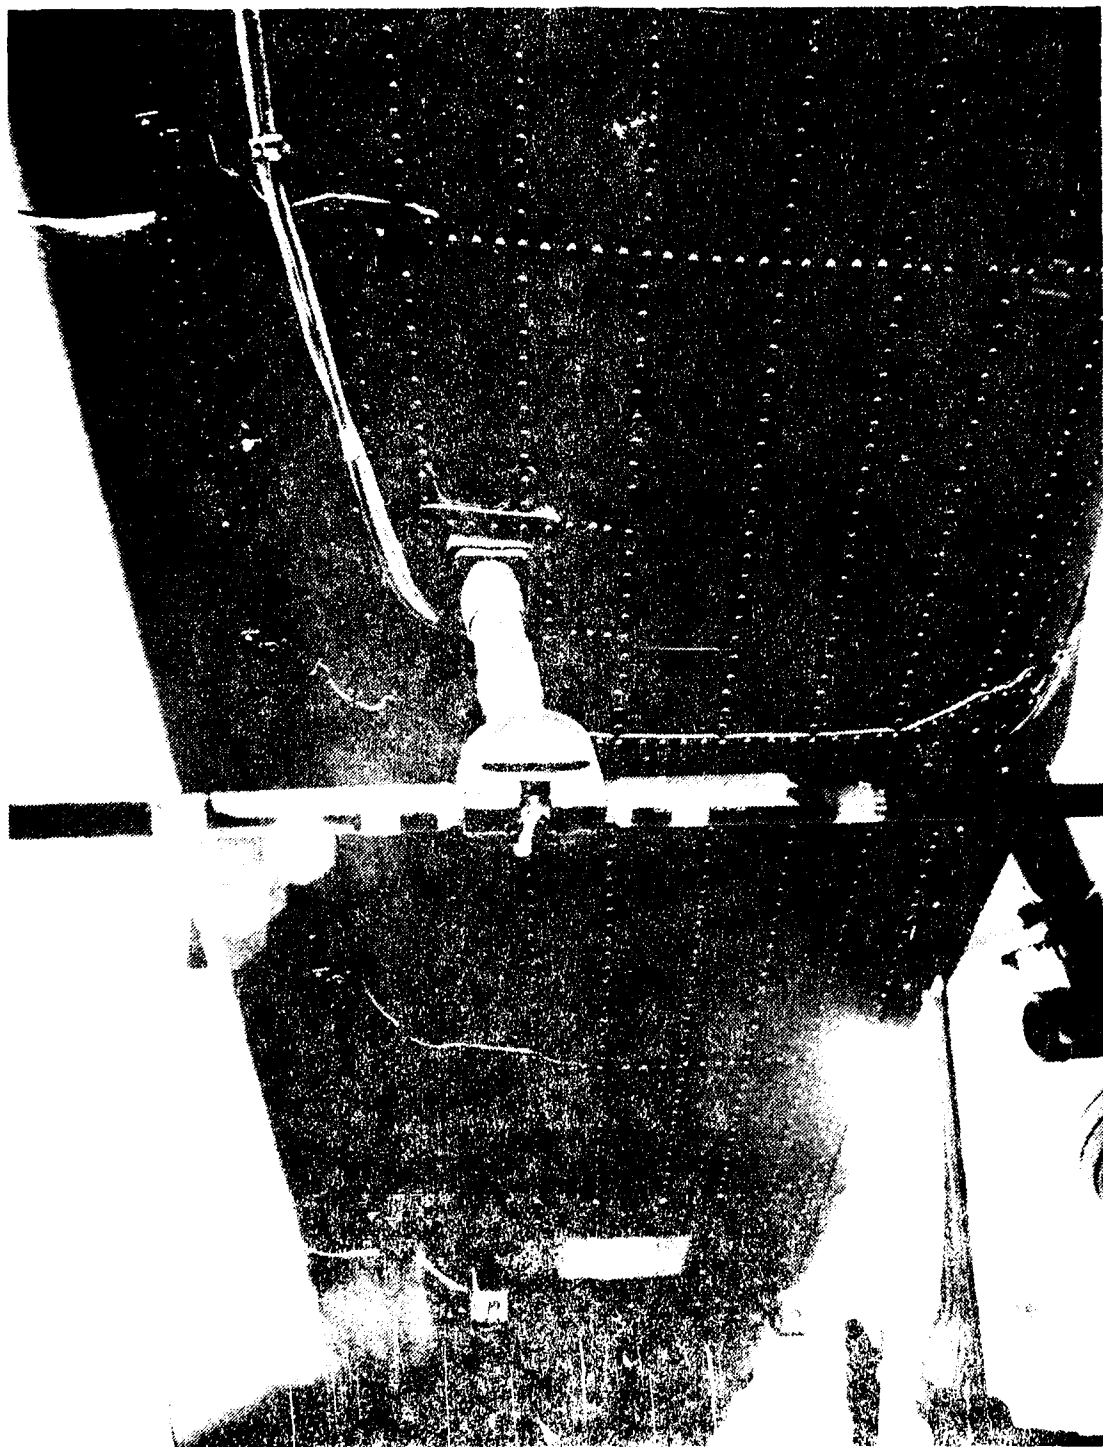
on the unheated sections of the DF antenna elements and supports is shown in photo 8, appendix H taken after an artificial icing flight during which the antenna was exposed to LWC ranging from 0.50 to 1.0 gm/m³ at -22.5°C for 30 minutes. No antenna oscillations were observed in artificial or natural icing or in clear air tests. The anti-iced DF dipole antenna was designed only to test the feasibility of antenna anti-icing and was not configured to DF. No electromagnetic interference was noted between the heated DF dipole antenna elements and other aircraft systems. The thermo-electrically anti-iced DF dipole antenna demonstrated safe operation in icing intensities through moderate, and has good potential for flight in icing conditions. Further testing of a production configured anti-iced DF dipole antenna should be accomplished in artificial and/or natural icing conditions to verify proper operation.

Photo 8. Ice Accretion on Unprotected Sections of Heated
Direction Finding Dipole Antenna - Artificial Icing -
1.0 gm/m³ LWC, -6.5°C, 43 Minutes, Flt #13

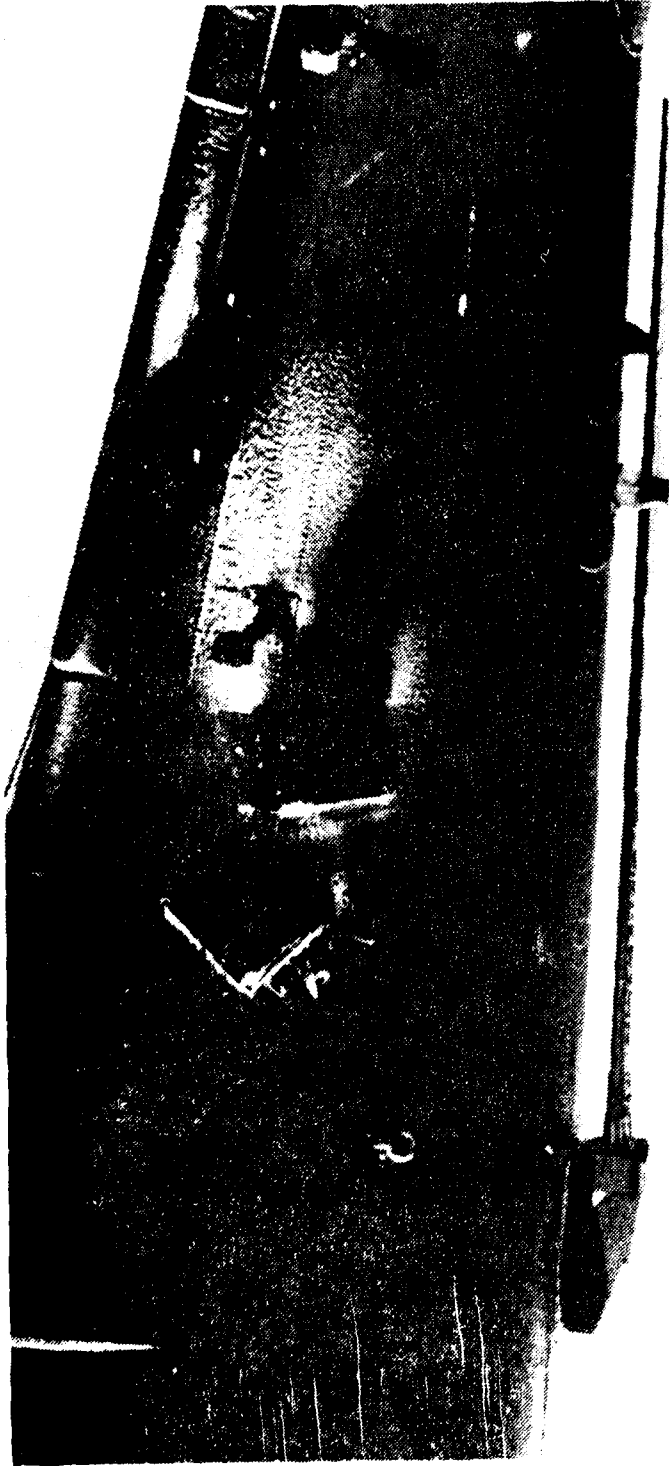
17. The ice accretion and shedding characteristics of the ECM antenna were evaluated at the specific test conditions listed in table 1, appendix F. The ECM antenna was iced in the retracted and extended positions. Typical ice accumulation on the extended antenna after 49 minutes exposure to artificial icing conditions at 1.0 gm/m³ LWC and -21.5°C is shown in photo 9, appendix H. Ice accumulation induced an oscillations on the ECM antenna causing tip deflections of up to ±1 foot. The oscillations also caused noticeable movement of ECM antenna actuation mechanism and the adjoining mounting structures. The oscillations occurred approximately every 10 minutes in moderate icing conditions and usually lasted between 10 and 30 seconds ending when the accumulation ice was shed. Shedding could also be induced by retracting and extending the ECM antenna (photo 10, app H). In the retracted position the ECM antenna and its actuation mechanism accumulated only small amounts of ice which did not prevent antenna extension or retraction. Post flight inspections revealed no damage to the antenna or the mount following icing encounters. The operational characteristics of the ECM antenna after ice accumulation or while oscillating were not evaluated. The excessive ECM antenna oscillations caused by ice accumulation are a shortcoming.

Photo 10. Induced Shedding - Electronic Countermeasures Antenna
Natural Icing - 0.25 gm/m³ LWC, -5.5°C, 69 Minutes, Flt #12

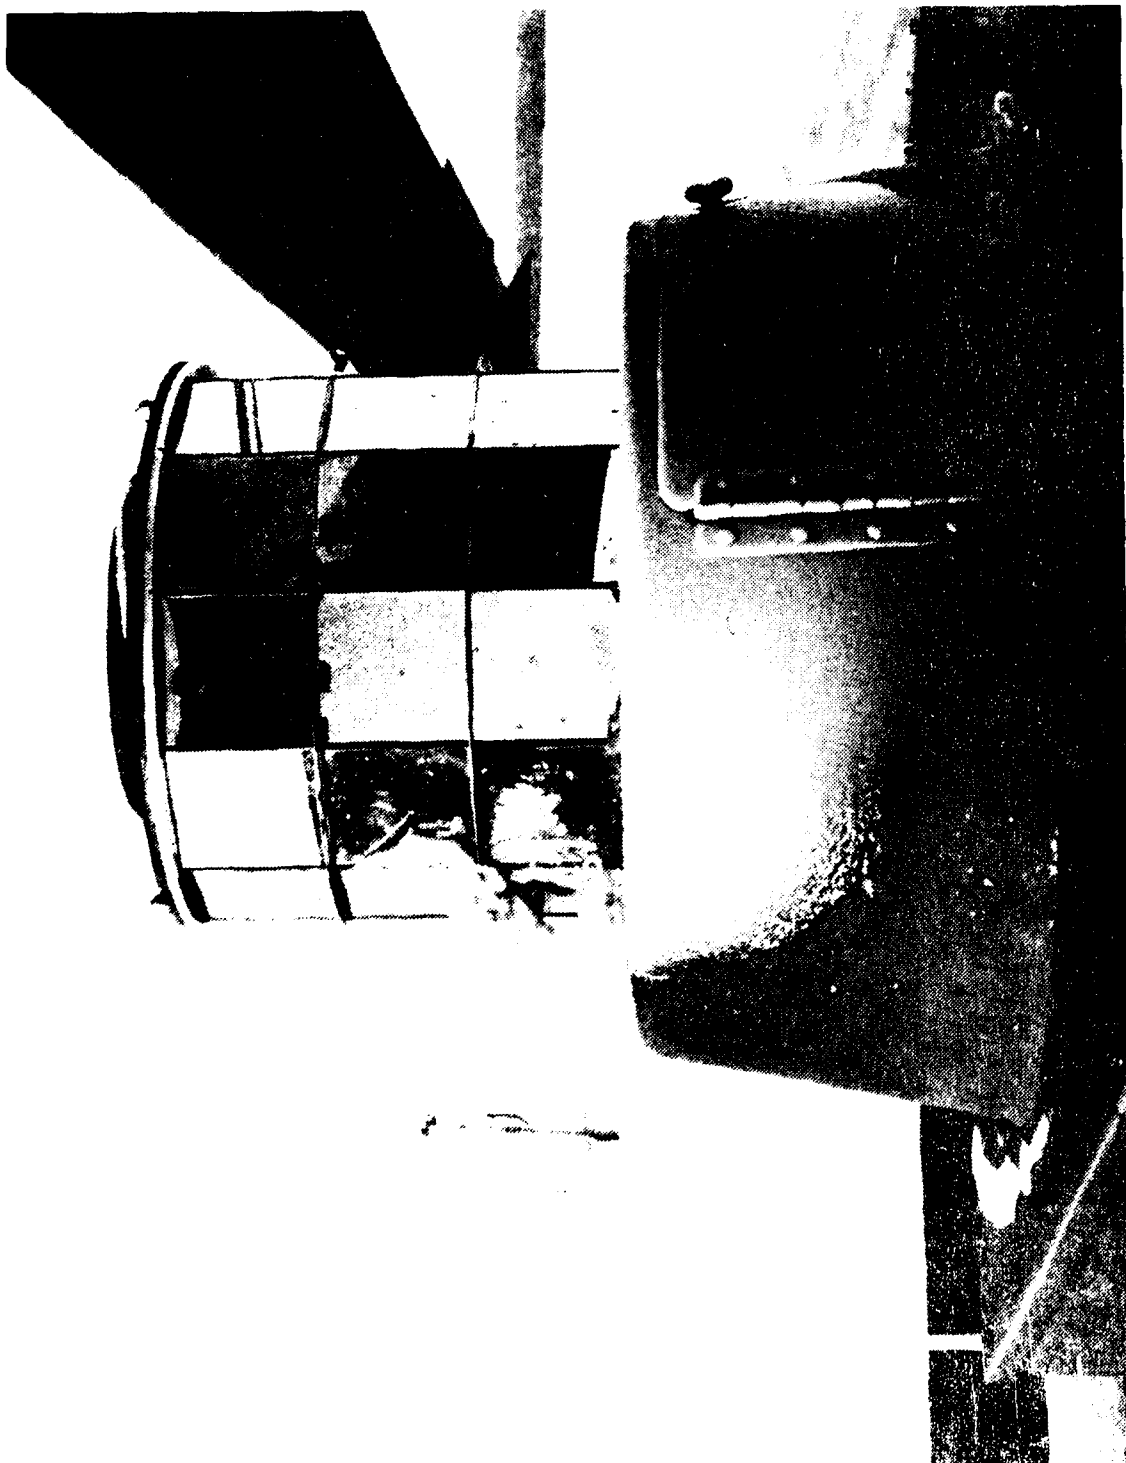
19. The ice accretion and shedding characteristics of the AN/ALQ-144(V) IR Countermeasures device were evaluated at the specific test conditions in table 1, appendix F. Those characteristics were documented in artificial and natural icing conditions as depicted in figures 1 and 2, appendix F, respectively. For most test flights the ALQ-144(V) was activated before entry into the icing conditions. Typical ice accumulation after a 28 minute flight in artificial icing conditions at 1.0 gm/m^3 LWC and -20.0°C is shown in photo 12, appendix H. To test the capability of the device to shed accumulated ice, the ALQ-144 was activated after an artificial icing encounter of 43 minutes at -6.5°C and an average LWC of 1.0 gm/m^3 . Activation of the ALQ-144 melted the ice touching the lens and the remaining ice shed naturally. Evaluating the effects of ice accumulation on the operating characteristics of the ALQ-144(V) was beyond the scope of these tests. The ice accumulations and subsequent sheds from the ALQ-144(V) after exposure to natural and artificial icing conditions did not adversely affect the operation of the helicopter. For the conditions tested, the ice accretion and shedding characteristics of the ALQ-144(V) IR countermeasures device are satisfactory.

Photo 12. Ice Accretion - An/ALQ-144(V) Infrared Countermeasure Set
Artificial Icing - 1.0 gm/m³ LWC. -20.0°C. 28 Minutes, Flt #1

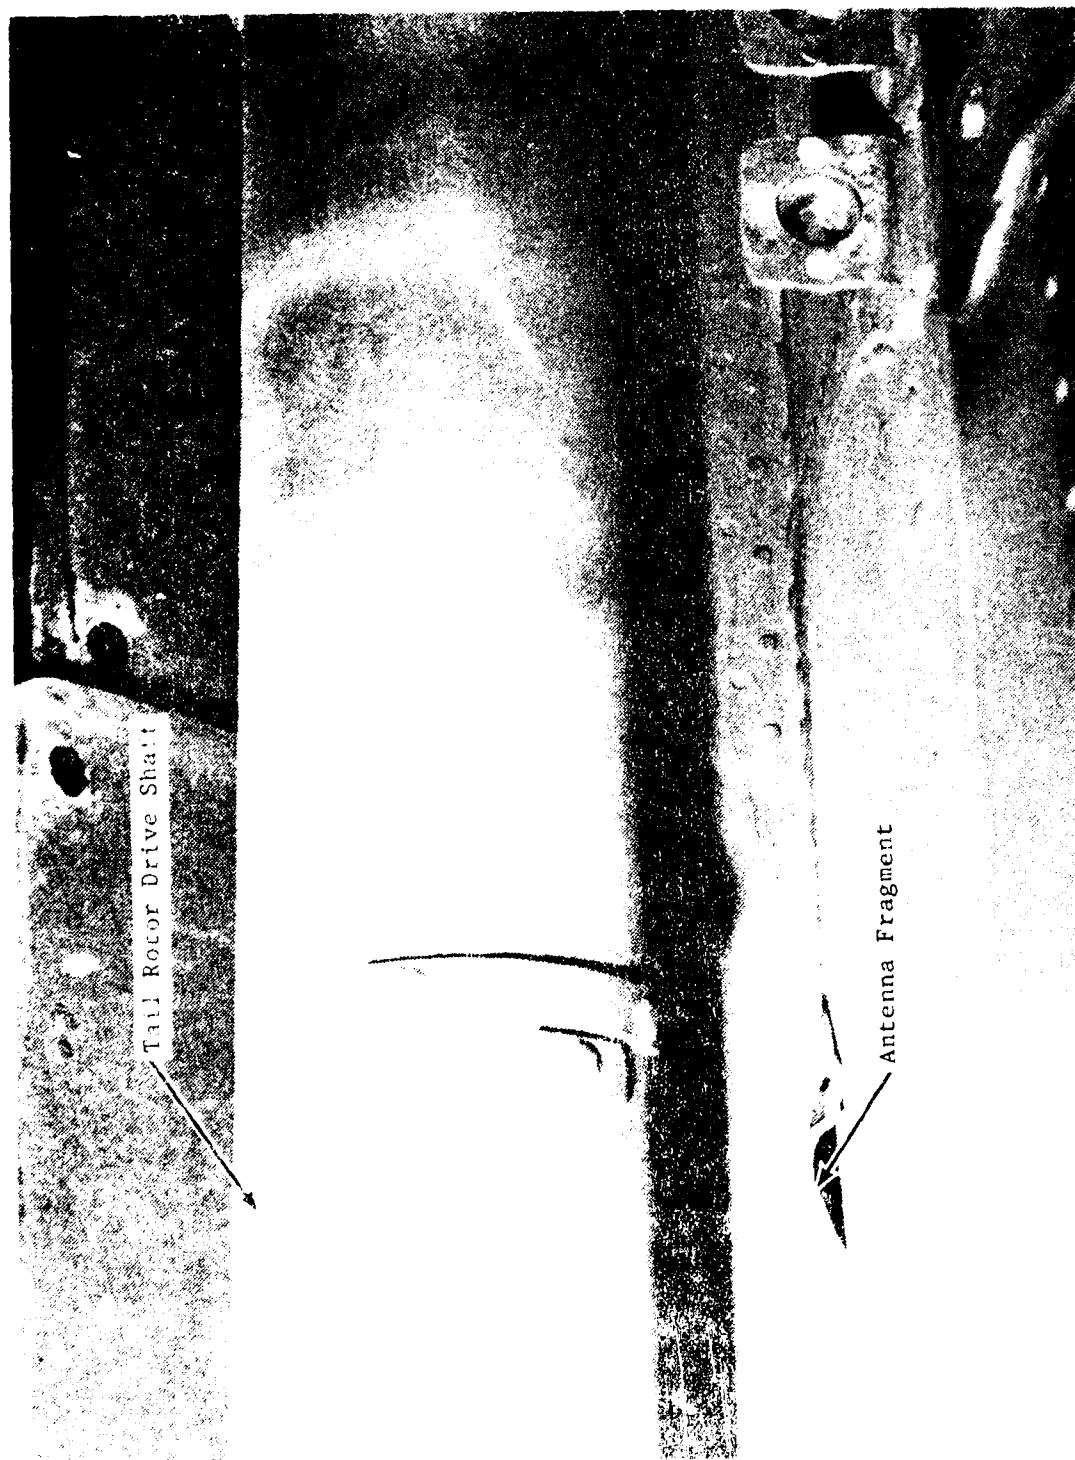
Photo 15. Ground Taxi Incident - Direction Finding Dipole Antenna #4 Fragment
